Marist Way

PROJECT:
Example

DRWG. TITLE:
Tree Survey/Scope

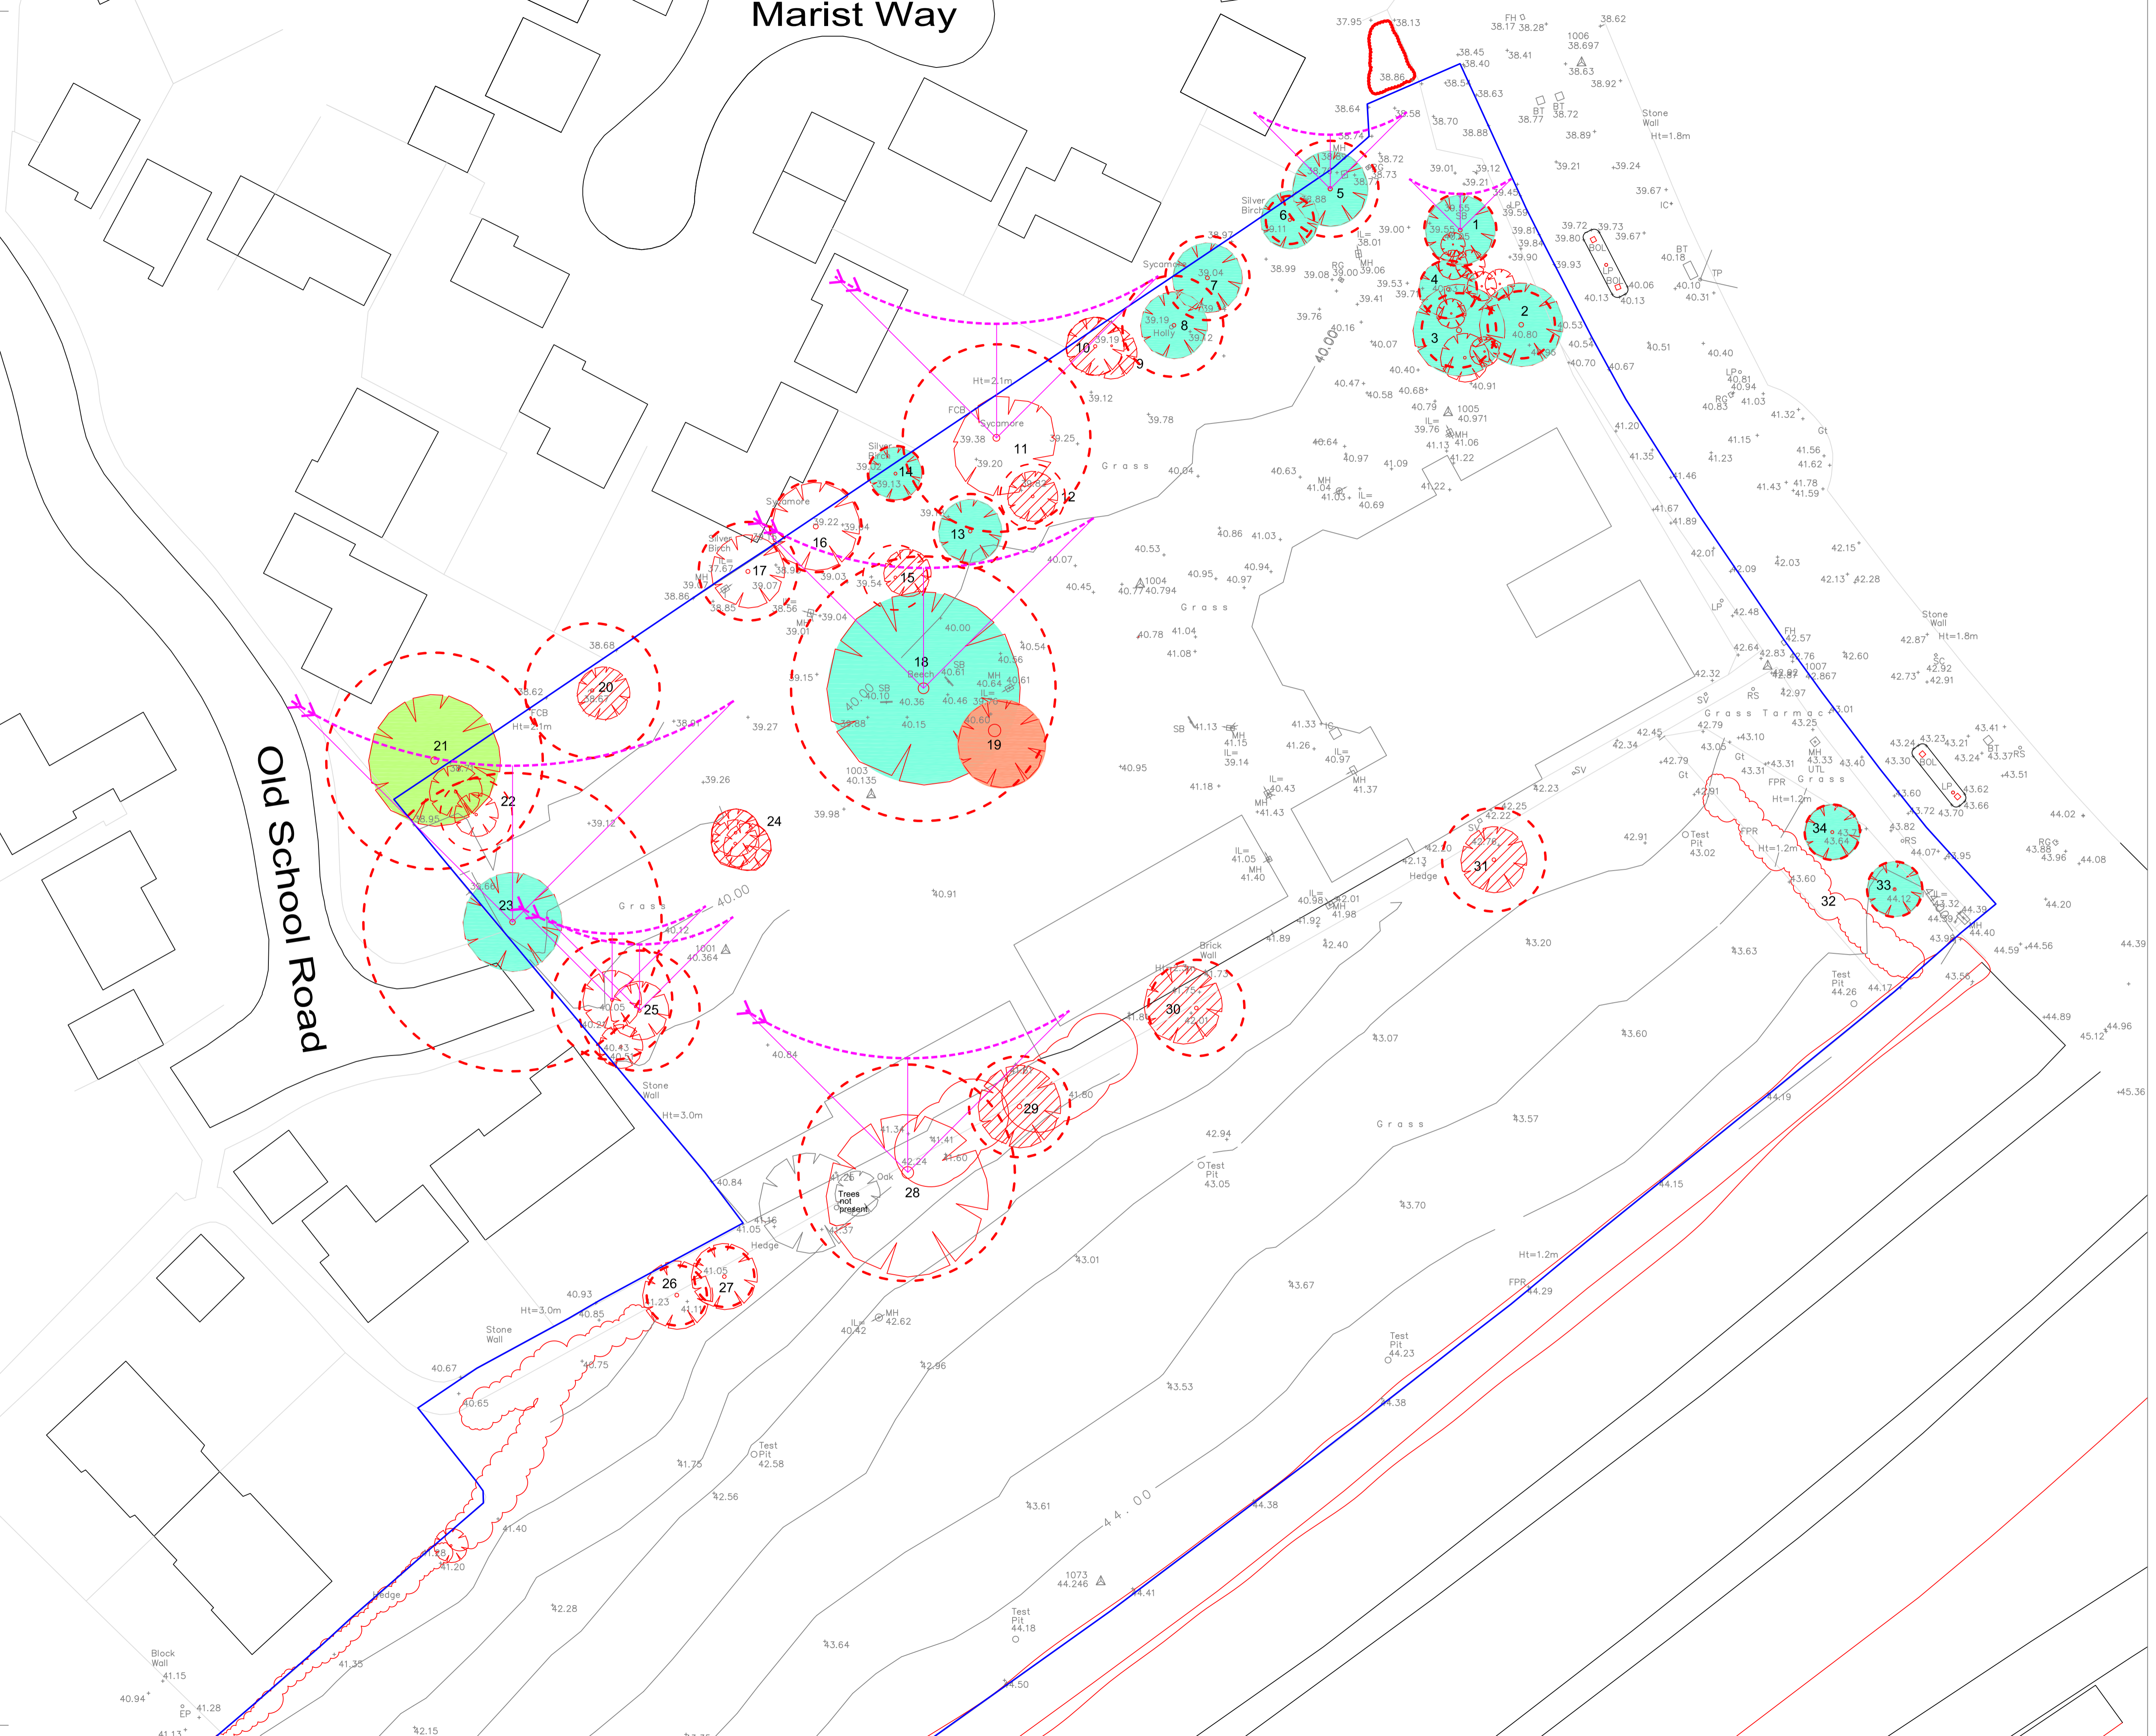
Tree with BS root protection area (shown uniform)
Root distribution may be modified by site features.

The BS rooting areas are to remain free from construction works which has the potential to damage or remove roots to an extent which may affect the condition of the tree.

Note:
Tree No 18 is a border line 'C' grade tree. Its merit is in its size and impact upon the landscape only. The tree is declining in condition and may not survive 20 years.

The shade trace for the relevant tree after APN5 21st June at 9.00am through to 3.00pm

Tree which could be removed
(Trees which are not hatched can also be removed but this would constitute a loss.)
